# Manhole Inspection Summary

Manhole # **S47G\_\_010MH**

Insp Date: **7/30/08 10:00 AM**

**Location** Address: **300 S Patterson Ave**

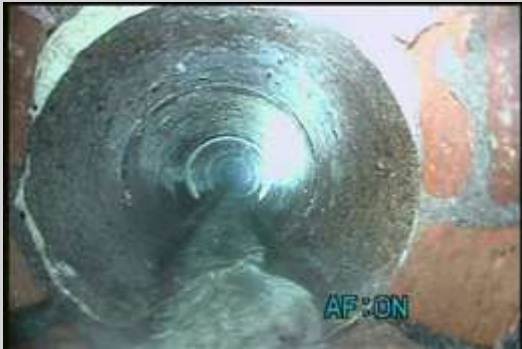
12 O'Clock Outflow

8 in. Circular Gravity Sewer  
Pipe Out @ 12 OClock

Pipe Material: **Clay** ☐ Pipe Lined

Invert Depth: **13.00** (ft.) Flow Characteristics: **Fast**

Infiltration: **None** Pipe Seal Cond: **Unknown**

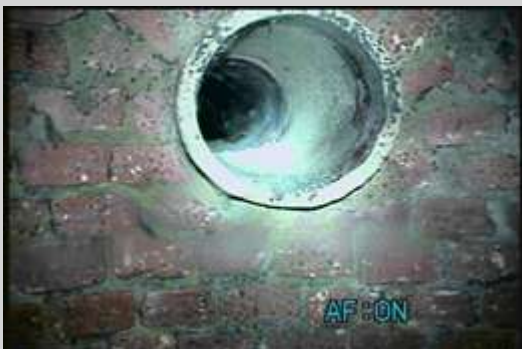
3 O'Clock Inflow

8 in. Circular Gravity Sewer  
Pipe In @ 3 OClock

Pipe Material: **Clay** ☐ Pipe Lined

Invert Depth: **8.16** (ft.) Flow Characteristics: **Fast**

Infiltration: **None** Pipe Seal Cond: **Unknown**

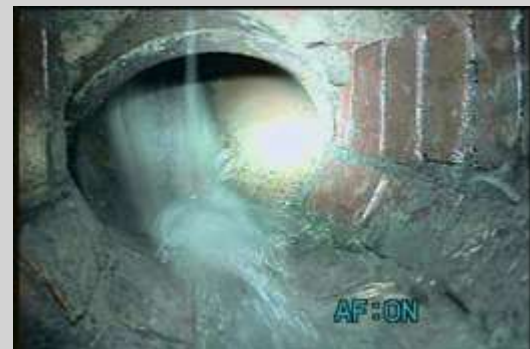
Drop In @ 3 OClock

Drop: **Inside** **Direct**

Inv Depth: **12.96** (ft.)

Drop Condition: **Open**

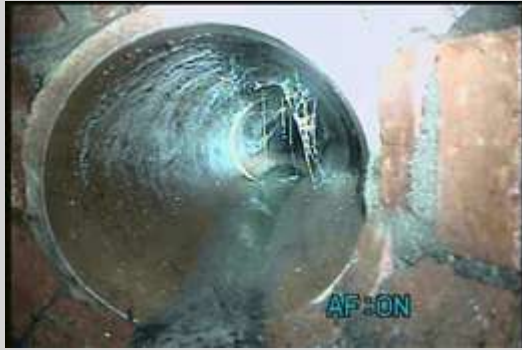
9 O'Clock Inflow

8 in. Circular Gravity Sewer

Pipe In @ 9 O'Clock

Pipe Material: **Clay** ☐ Pipe Lined

Infiltration: **None** Pipe Seal Cond: **Unknown**
